Vattenfall AB Heat Generation Uppsala

Major Overhaul 200 MW Turbine; OEM vs Non-OEM

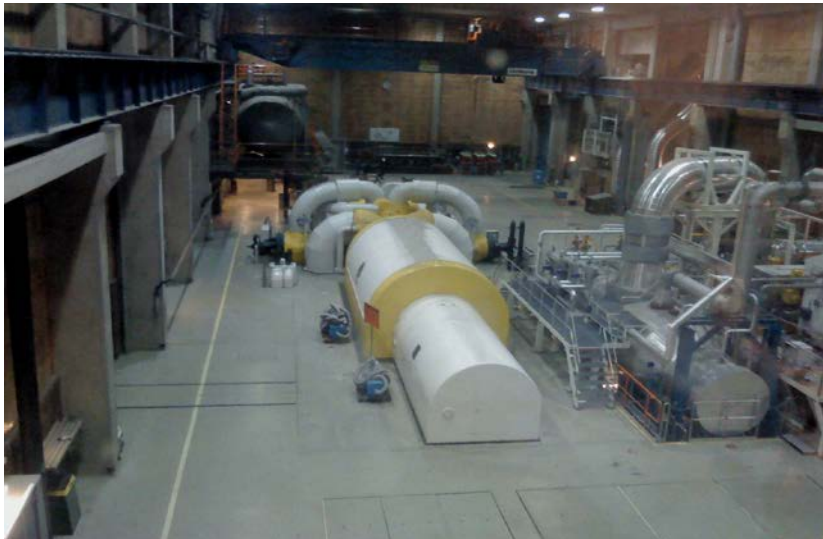
Remaining Lifetime Study

- Major steam turbine components of conventional power plants like Uppsala T7080 are exposed to creep damage and low cycle fatigue, which grow continuously over the operating period.
- This remaining lifetime analysis for the HP and IP turbine rotors is intended to derive a recommendation, if the inlet and first blade grooves should be machined during the major outage planned for 2013.
- An operation until 2020 with finally 165,000 operational hours and 616 starts is planned for the steam turbine.

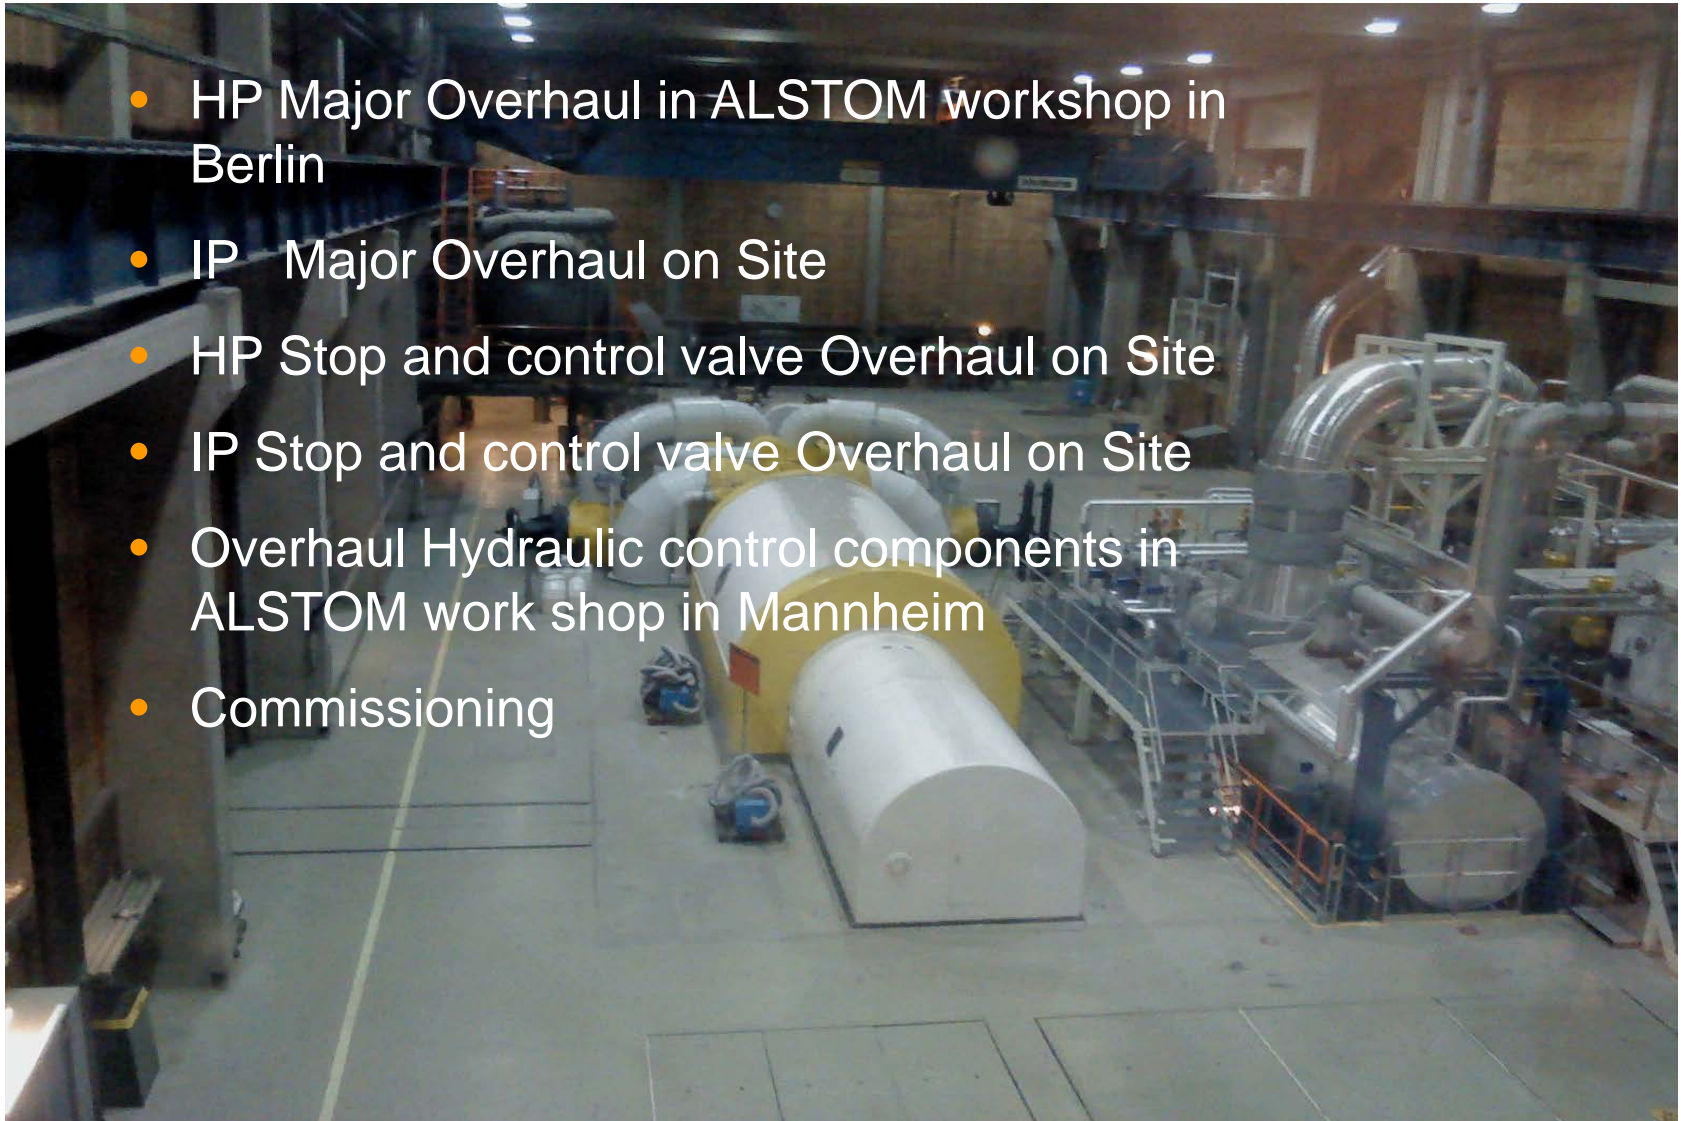
ALSTOM purchased a retired turbine for development and training

To develop and ensure the capability to maintain this specific barrel type HP turbine ALSTOM purchased a retired turbine from a sister plant in Norrköping (Bråvalla)

- Build up know how for the special assembly and disassembly process of barrel type turbines
- Train Field Service personnel for Erection and TFA in Berlin
- Reverse engineering

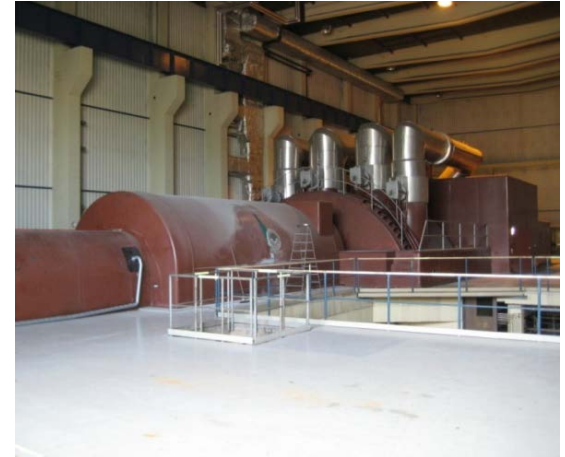
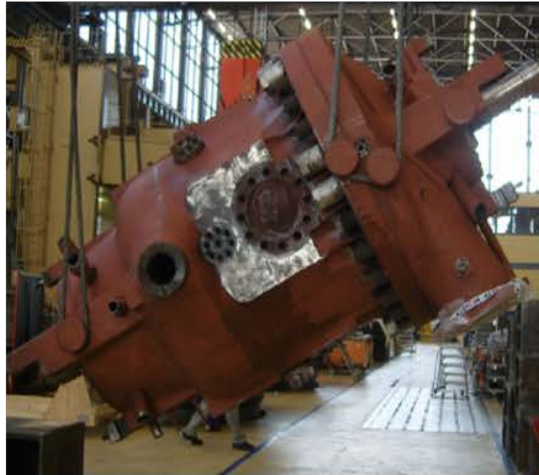
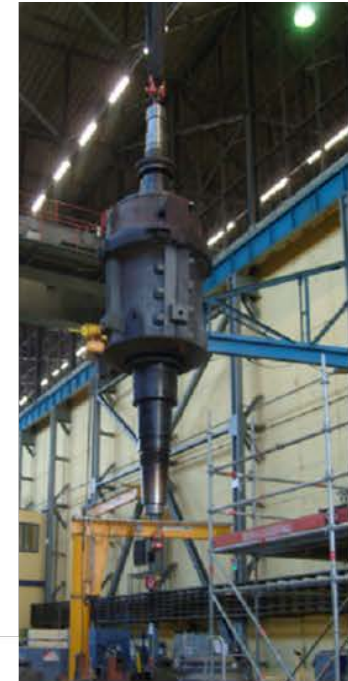
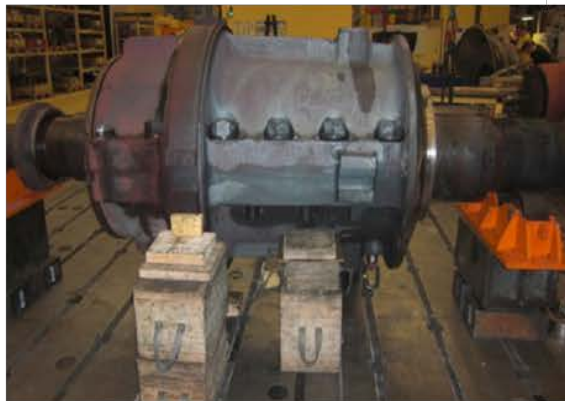
Virtuell as well as physical assembly training on the barrel type HP turbine

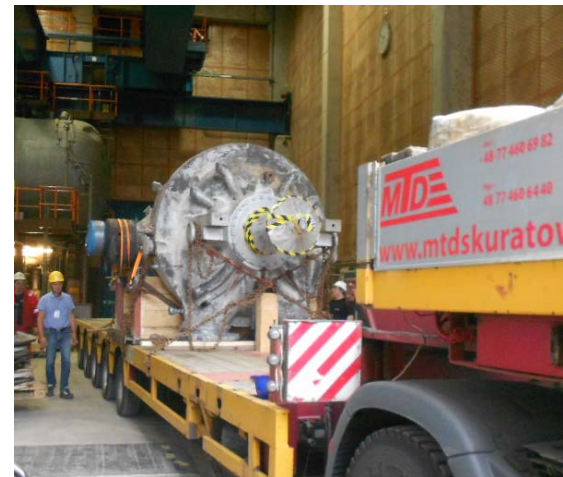
The HP Turbine of barrel type was overhauled in Alstom service workshop in Berlin

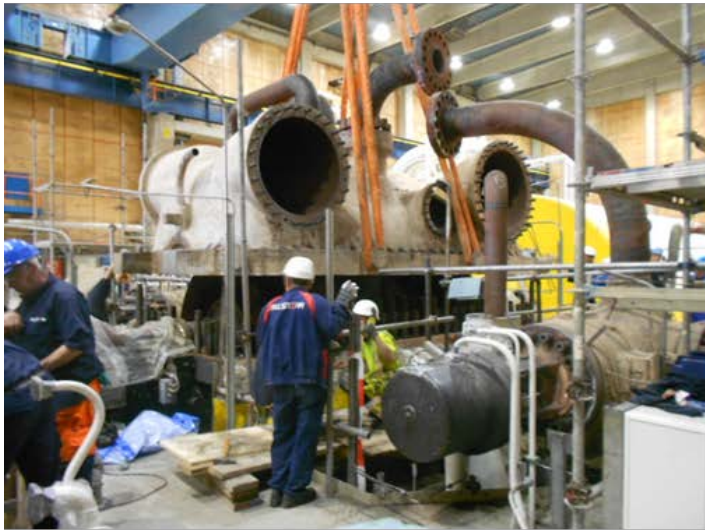
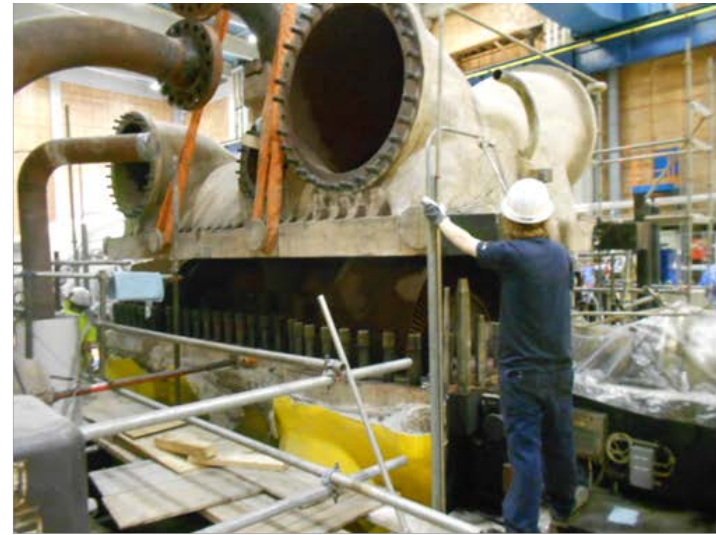
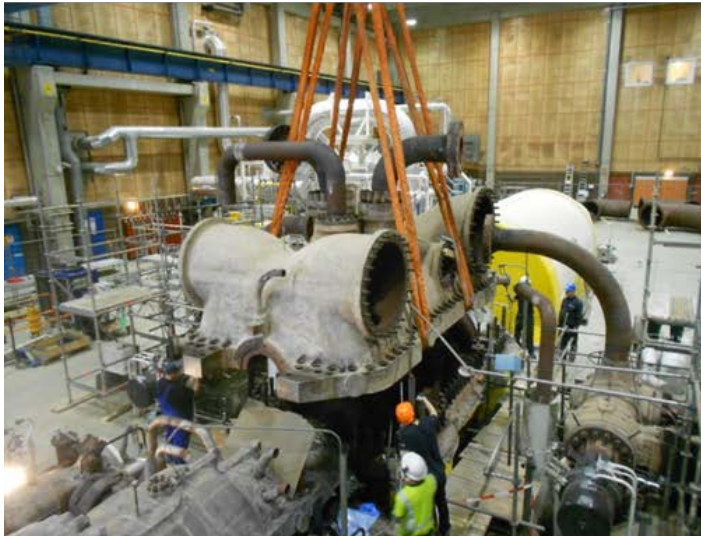
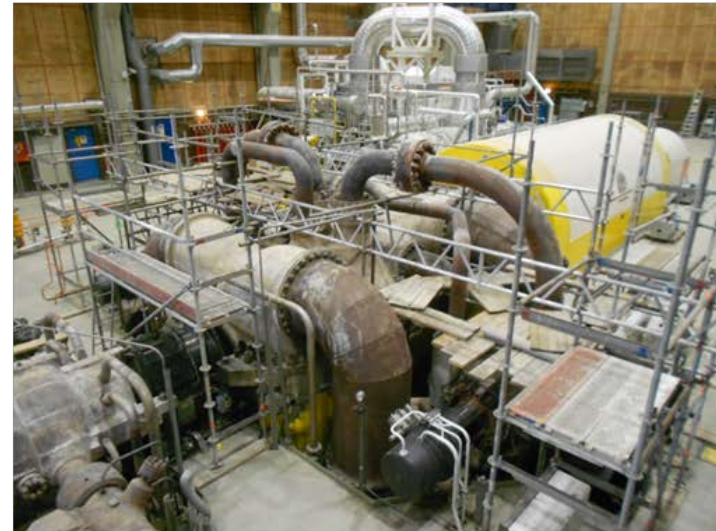
Overhaul of the MP turbine and main steam valves at the site in Uppsala

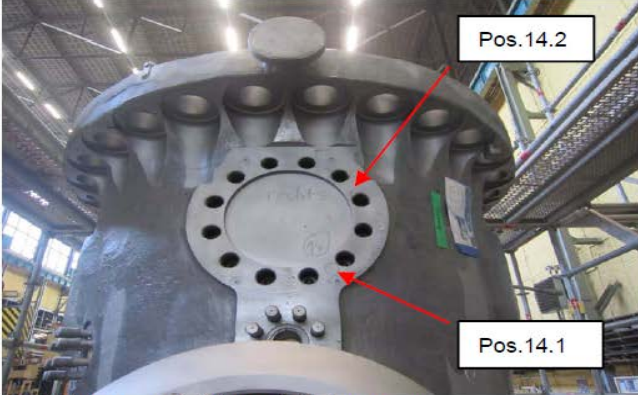
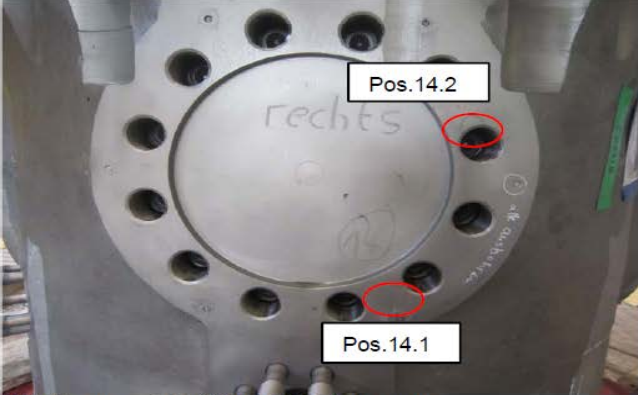
Bild / pict. 34 Übersicht / overview rechts / right	Bild / pict. 35 Übersicht / overview rechts / right

Cracks, outer turbine casing, HT

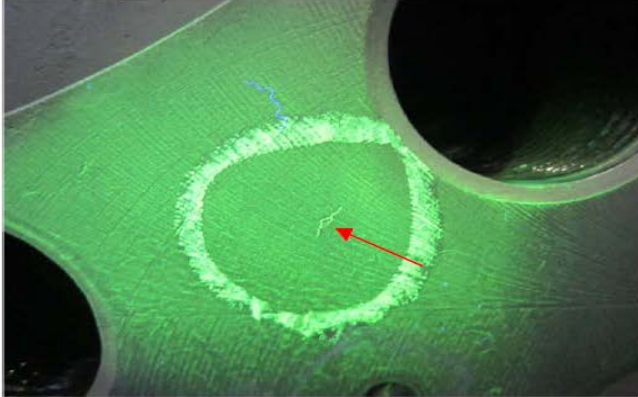
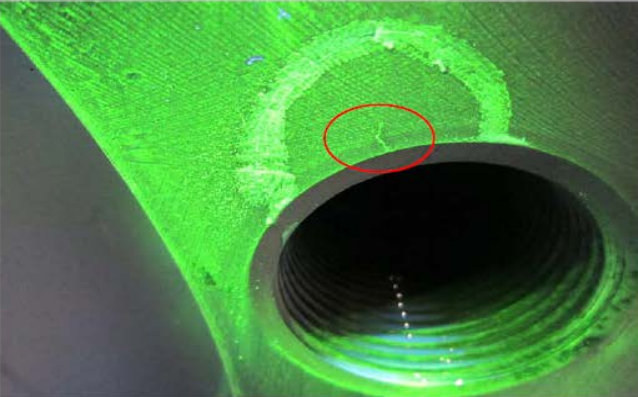
Bild / pict. 36 Detail / detail lineare Anzeige 10mm <i>linear indication 10mm</i>	Bild / pict. 37 Detail / detail lineare Anzeige 6mm <i>linear indication 6mm</i>	Pos.14.1	Pos.14.2

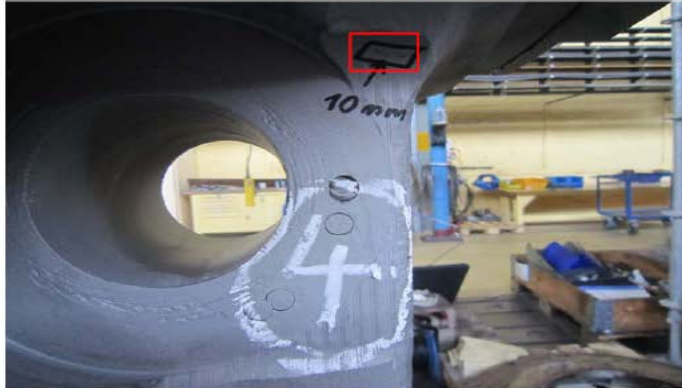
Bild / pict. 7 Übersicht / overview Pos.4

Cracks, inner turbine casing, HP

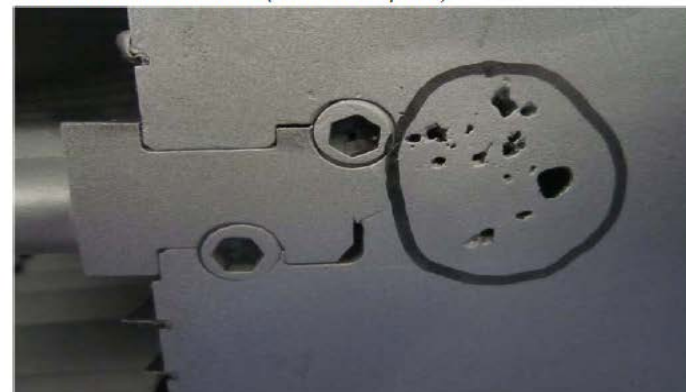
Bild / pict. 10 Detail / detail Pos.5
 Lunkenfeld Ø 25mm mit Einzelanzeigen 1-5mm
 blow hole Ø 25mm with single indications 1-5mm

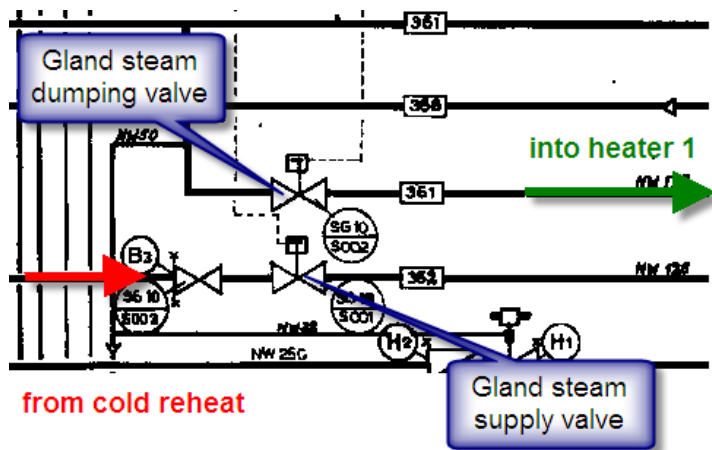
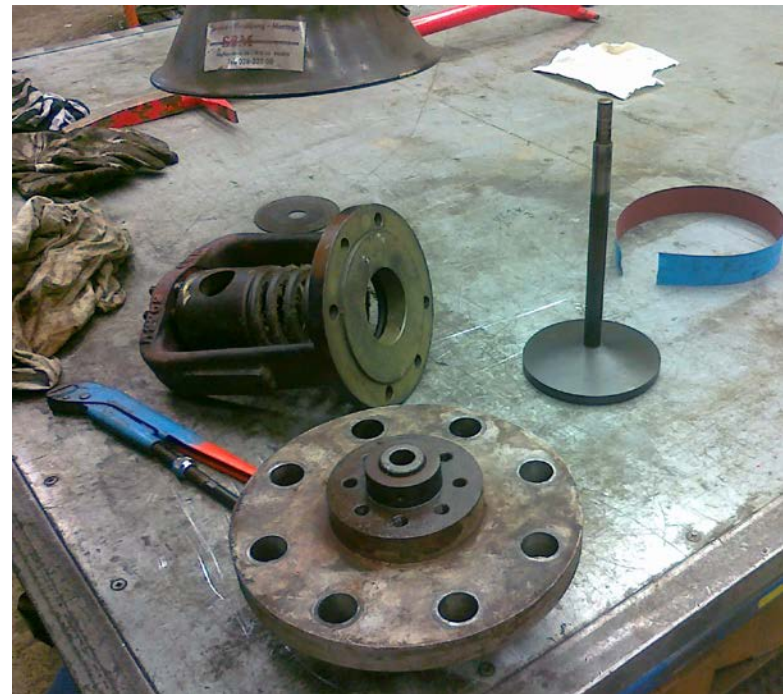
Trouble shooting of a steam leakage problem occurred after a few weeks of operation

- Steam leakage at the HP main steam emergency safety valve as well as at the MP turbine shaft sealing glands
- Several trouble shooting activities revealed a problem with a gland steam dumping valve
